Manhole Inspection Summary

Manhole # S35SS1015MH

Insp Date: **2/8/07 11:38 AM**

Location Address: **409 WOODFORD RD**

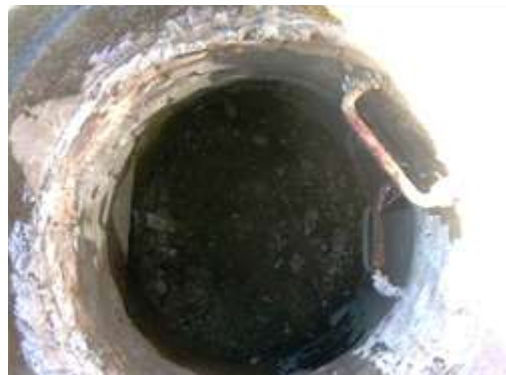
Top View

Corroded steps. Channel debris.

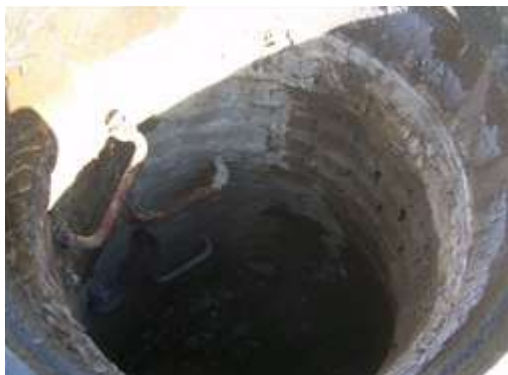
Defect

Adjustment deterioration and infiltration.
Corbel and Barrel infiltration - other side.

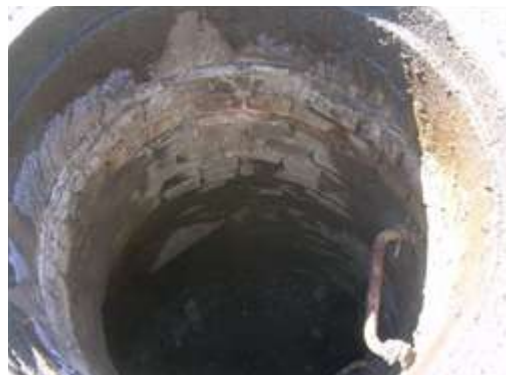
Defect

Adjustment deterioration and infiltration.
Corbel and Barrel infiltration.

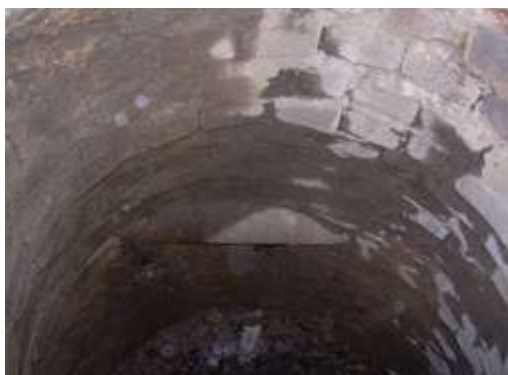
Defect

Adjustment, Corbel and Barrel infiltration.
Unknown pipe running through the MH

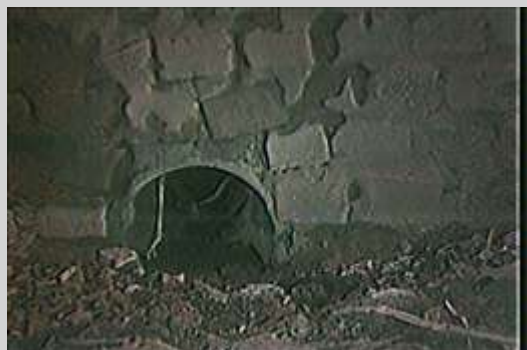
Pipe Out @ 12 O'Clock

Deposits: ☐ None ☒ **Mud** ☐ Sludge ☒ **Debris** ☐ Grease

Pipe Seal Cond: **Cracked**
